# Frigstad Home Inspections

## "Home Inspection Report"

**Inspection date: Thursday, June 30, 2005**

**Report number:** 050630B

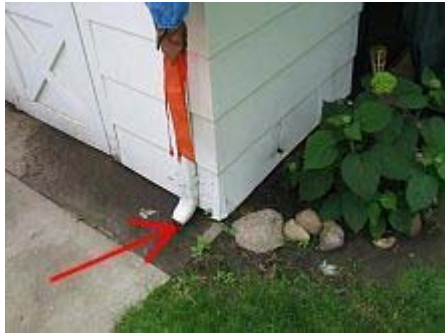
<p><b>2)</b> One downspouthas no extensions on the northwest corner, or have extensions that are ineffective. This can result in water accumulating around the structure's foundation, or in basements and crawl spaces if they exist. Accumulated water is a conducive condition to wood destroying insects and organisms, and may also cause the foundation to settle and possibly fail over time. Recommend making repairs as necessary such as repairing or installing splash blocks or tie-ins to underground drain lines so rain water is carried at least several feet away from the structure to soil that slopes down and away from the structure.</p>

<p><b>Photo 5</b> No extension on the downspout</p>
<b>i</b>	<b>3)</b> Minor cracks were found in the driveway. These are only a cosmetic concern and no action is recommended.

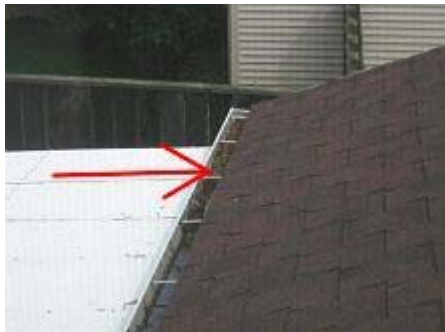
<b>i</b>	<p><b>4)</b> The gutters should be cleaned, so the water can drain faster.</p>

<p><b>Photo 2</b> Gutters should be cleaned</p>
----------	--

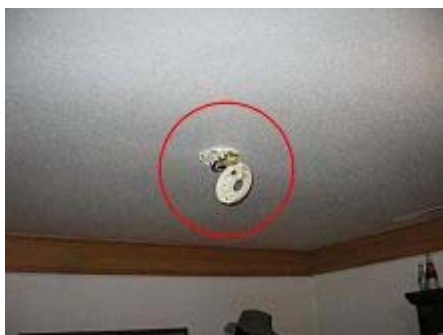
<p><b>7)</b> One or more smoke detectors is damaged or missing, and an insufficient number of smoke detectors are installed. Recommend replacing inoperable smoke detectors as necessary, and installing additional smoke detectors as necessary so a functioning one exists in each hallway leading to bedrooms, and in each bedroom. For more information on smoke detectors visit <a href="http://www.cpsc.gov/cpscpub/pubs/5077.html">http://www.cpsc.gov/cpscpub/pubs/5077.html</a></p>
---	--

**Photo 3**  
Smoke detector in the basement
